# Examination of the effect of aging process on marginal fit and fracture strength of temporary crowns prepared from different materials

Bahriye Bahar Tüfekçi<sup>a,\*</sup>, Zeynep Yeşil<sup>b</sup><sup>a</sup> Prosthodontics Specialist, Trabzon Oral and Dental Health Hospital, Trabzon, Turkey<sup>b</sup> Recep Tayyip Erdoğan University Faculty of Dentistry, Rize, Turkey and Atatürk University Faculty of Dentistry, Erzurum, Turkey

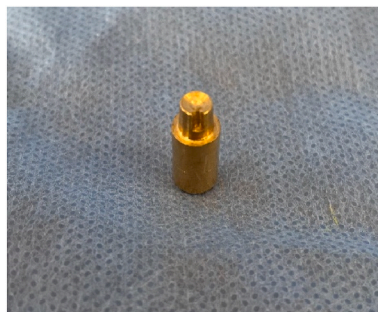
The dies representing the prepared maxillary first premolar tooth, through which samples would be obtained, were prepared on a C turning machine (Space Turn LB2000, Okuma Corp, Japan) with 5 mm crown length and 6° taper angle with 1 mm chamfer finish line with anatomical occlusal surface in order to ensure standardization (Fig. 1).

Fig. 1. Steel die used in the study.

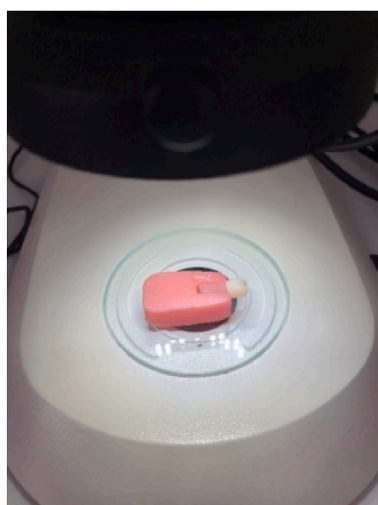
In order to keep the samples in the same position during the evaluation of their marginal fit, a carrier was prepared from autopolymerized acrylic resin (Fig. 4).

Fig. 4. Carrier mechanism prepared from autopolymerized acrylic resin.

The marginal gap of the crowns placed in the mechanism prepared from autopolymerized acrylic resin was made by rotating the samples clockwise from the regions where the guide points were located, and 20 measurements for each sample were made using a stereomicroscope (Carl Zeiss AG, Oberkochen, Germany) under ×40 magnification (Fig. 5). All measurements were calculated in micrometers (µm). The average of the measurements for each crown was then taken and recorded as the marginal gap value of the relevant sample.

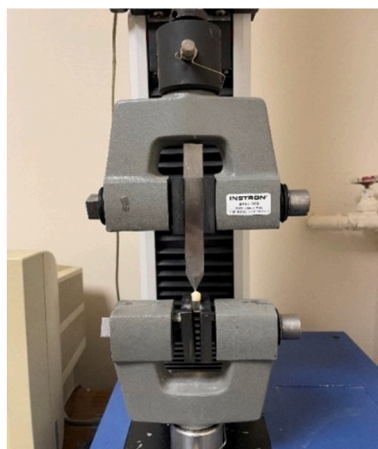
Evaluation of fracture resistance was performed using Instron Universal tester (Instron Corp, USA) (Fig. 6). Temporary crowns were placed at a right angle on the tray designed to remain immobile during force application. Speed of Instron header was set at 1.5 mm/min and force was applied to the palatal tubercle of the crowns in a continuously increasing manner until the first fracture occurred. The data obtained were recorded in Newton (N) to the device's own software and data were statistically analyzed using Jamovi 2,2,5 statistical program (Sydney, Australia).

Fig. 6. Instron Universal tester.

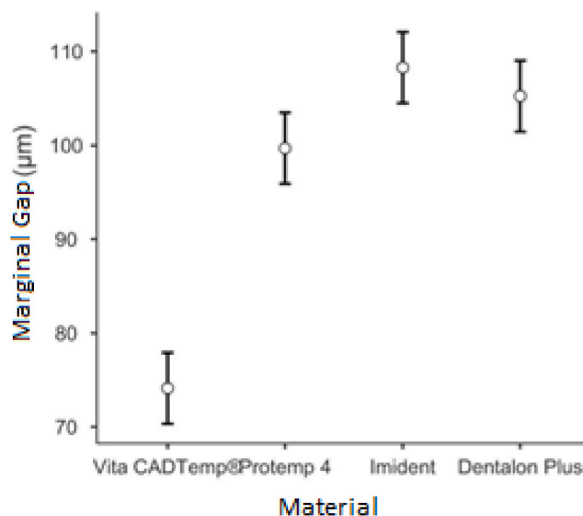
Comparison of marginal gap values between four types temporary crowns prepared with non-aging process revealed the association of the poly acrylic resin (Vita CADTemp®) temporary crowns prepared by CAD/CAM method with the best marginal gap values compared to the crowns prepared by other materials ( $p < 0.001$ ). The marginal gap values were also significantly better for the bisacryl composite resin (Protemp 4) temporary crowns compared to the poly methyl methacrylate (Imident) crowns (Fig. 8, Table 3).

Fig. 8. Graphical representation of marginal gap values of temporary crowns without aging process (95% confidence interval).

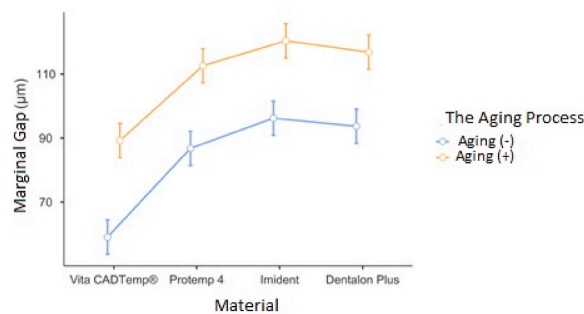
For each type of temporary crown, marginal gap values obtained without application of aging process were significantly lower than those obtained in the setting of aging process ( $p < 0.001$  for each) (Table 5, Fig. 10).

**Fig. 10.** Graphical representation of marginal gap values of temporary crowns made of different materials according to the aging process (95% confidence interval).

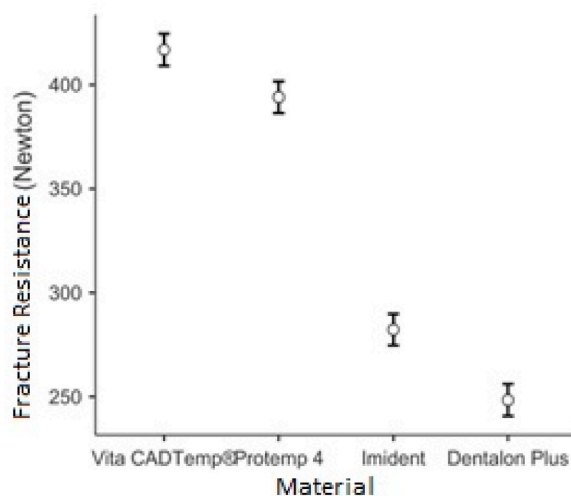
For the non-aged temporary crowns, poly acrylic resin (Vita CADTemp®) temporary crowns prepared using CAD/CAM method showed significantly (p < 0.001) higher fracture resistance values than temporary crowns prepared using all other materials (Protemp 4, Imident and Dentalon Plus). Also, temporary crowns prepared using PMMA (Imident) showed significantly (p < 0.001) higher fracture resistance values than temporary crowns prepared using PEMA (Dentalon Plus) (Fig. 16, Table 7).

Fig. 16. Graphical representation of fracture resistance values of non-aging process temporary crowns (95% confidence interval).

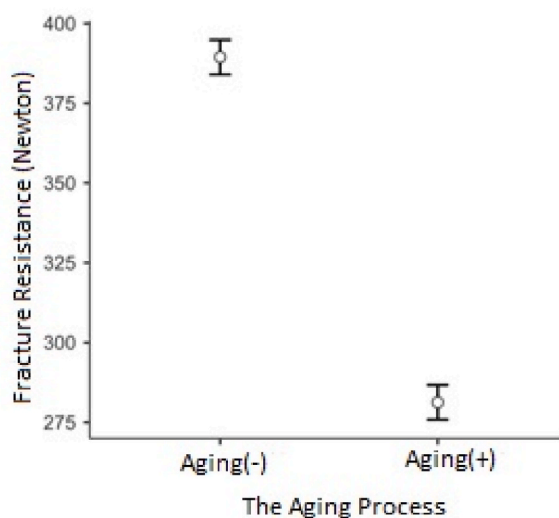
Regardless of the materials used, aged temporary crowns showed significantly (p < 0.001) lower fracture resistance values compared to non-aged temporary crowns (Fig. 17, Table 8).

Fig. 17. Graphical representation of the fracture resistance values of aging and non-aging process temporary crowns, regardless of material type (95% confidence interval).

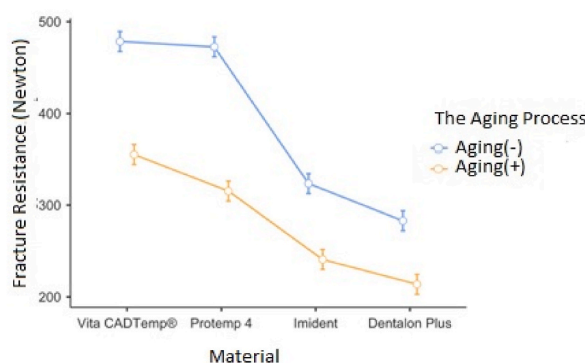
For each type of temporary crown, fracture resistance values obtained without application of aging process were significantly higher than those obtained in the setting of aging process ( $p < 0.001$  for each) (Table 9, Fig. 18).

**Fig. 18.** Graphical representation of fracture resistance values of temporary crowns prepared from different materials according to the aging process (95% confidence interval).
